**Flood Control Project Maintenance
Levee Inspections****LMA District Cover Sheet****Spring 2015 Levee Inspection Results****Solano County Public Works Mellin Levee**

Spring 2015 Levee Inspection Results

Solano County Public Works Mellin Levee

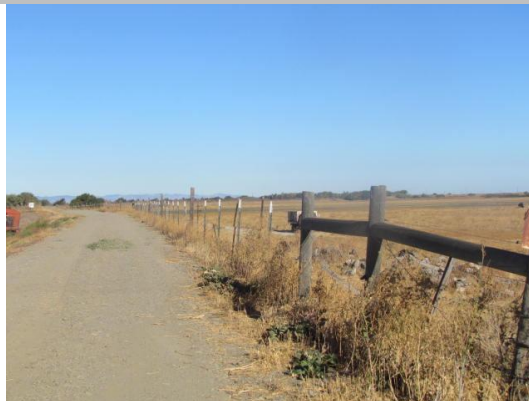
Photo 1 of 1 : SP_2015_NA0012_258_3_20150309_00002.jpg

LM Start	0.01	Rating **	M	Issue No.	3
LM End	0.49	Issue Type +	En	Location *	WS
Category	Earthen Levee			GPS Latitude/Longitude	
				Start	End
Item	Encroachments			38.174167 °	38.178960 °
				-121.674312 °	-121.680600 °
DWR ID	DWR_NA0012_01_s _ 2012_3				
Action/Comments					
Fence

Looking west at fence on waterside shoulder.

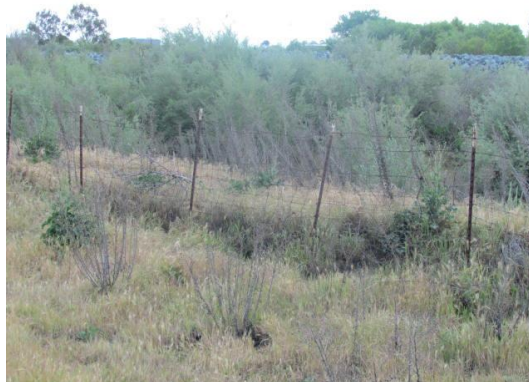
Photo 1 of 1 : SP_2015_NA0012_258_4_20150409_00005.jpg

LM Start	0.10	Rating **	M	Issue No.	4
LM End	0.28	Issue Type +	En	Location *	LS
Category	Earthen Levee			GPS Latitude/Longitude	
				Start	End
Item	Encroachments			38.175115 °	38.176805 °
				-121.675463 °	-121.677893 °
DWR ID	DWR_NA0012_01_s _ 2012_4				
Action/Comments					
Fence

Looking southeast at fence on landward slope.

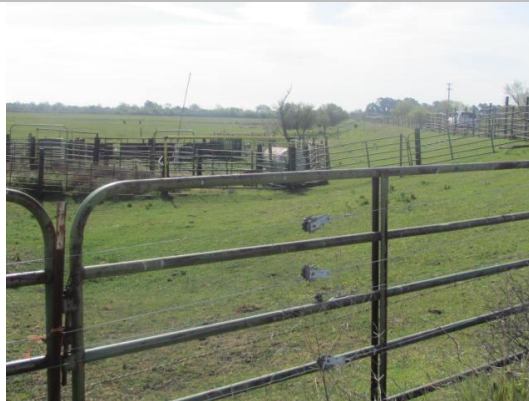
Photo 1 of 2 : SP_2015_NA0012_258_5_20150309_00003.jpg

LM Start	0.57	Rating **	M	Issue No.	5
LM End	0.59	Issue Type +	En	Location *	WS
Category	Earthen Levee			GPS Latitude/Longitude	
				Start	End
Item	Encroachments			38.179783 °	38.180027 °
				-121.681648 °	-121.681978 °
DWR ID	DWR_NA0012_01_s _ 2012_5				
Action/Comments					
Fence					
Inspector Comments: Animal corral.

Looking east at animal corral on waterside toe.

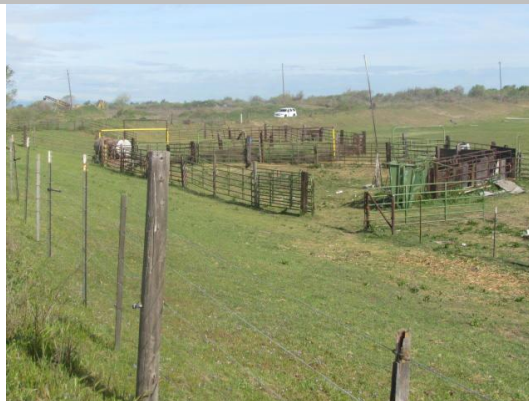
Photo 2 of 2 : SP_2015_NA0012_258_5_20150309_00004.jpg

Looking west at animal corral on waterside toe.

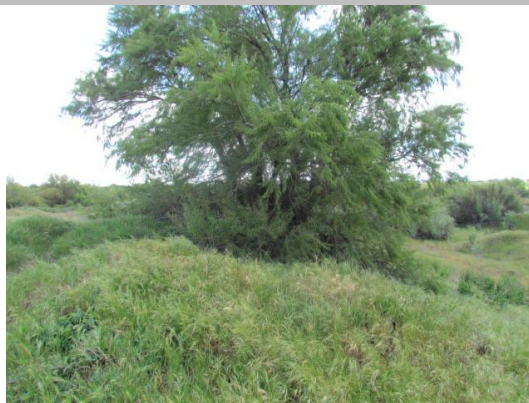
Photo 1 of 1 : SP_2015_NA0012_258_12_20150409_00008.jpg

LM Start	0.58	Rating **	M	Issue No.	12
LM End	0.58	Issue Type +	Ma	Location *	LS
Category	Earthen Levee			GPS Latitude/Longitude	
				Start	End
Item	Trim / Thin Trees			38.179966 °	38.179966 °
				-121.681872 °	-121.681872 °
DWR ID	DWR_NA0012_01_s _ 2015_12				
Action/Comments					
Trim trees to at least five feet above ground level.

Looking east at untrimmed tree on landward slope.
